Manhole Inspection Summary

Manhole # S15II_008MH

Insp Date: **10/29/07 2:08 PM**

Location Address: **REAR 1738 THOMAS**

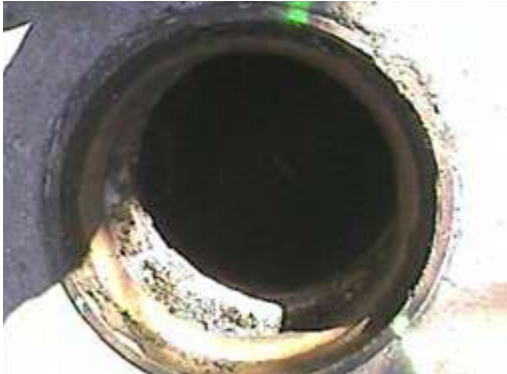
Top View

Frame Offset: **3** (in.) Condition: ☒ Sound ☐ Cracked ☐ Leaks

Frame offset

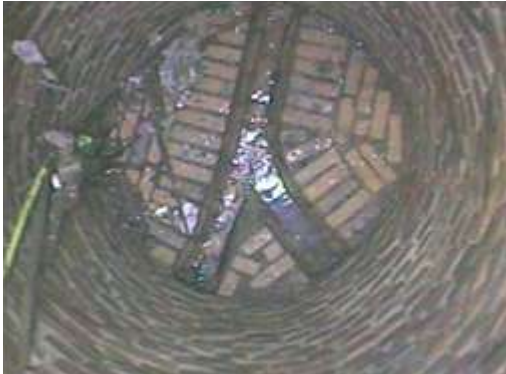
Defect 1

Surcharge ☒ **Evidence Of Surcharge** Depth: **3** (ft.) ☐ Active Surcharge Present

EVIDENCE OF SURCHARGE

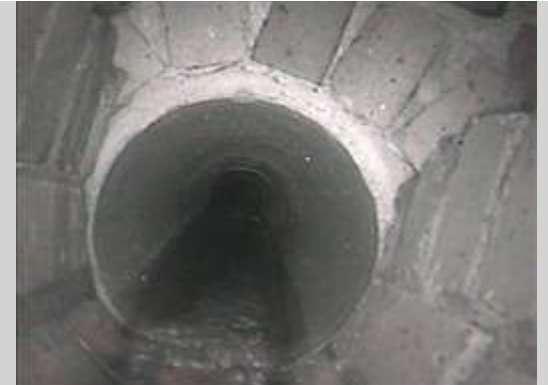
12 O'Clock Outflow

8 in. Circular Gravity Sewer
Pipe Out @ 12 O'Clock

Pipe Material: **Clay** ☐ Pipe Lined

Invert Depth: **12.15** (ft.) Flow Characteristics: **Slow**

Infiltration: **None** Pipe Seal Cond: **Sound**

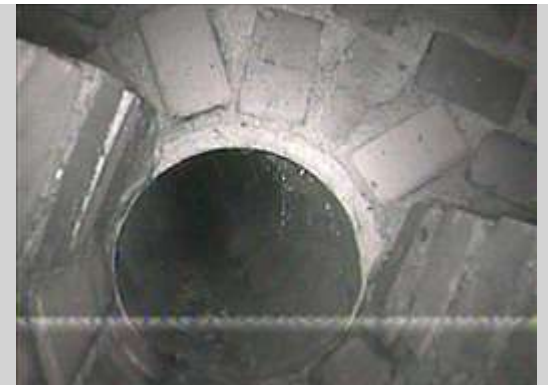
5 O'Clock Inflow

8 in. Circular Gravity Sewer
Pipe In @ 5 O'Clock

Pipe Material: **Clay** ☐ Pipe Lined

Invert Depth: **12.10** (ft.) Flow Characteristics: **Slow**

Infiltration: **None** Pipe Seal Cond: **Sound**

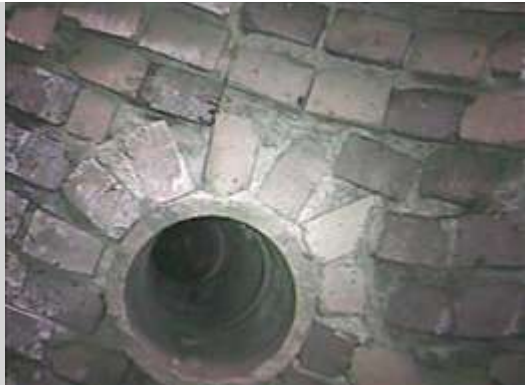
6 O'Clock Inflow

Pipe In @ 6 O'Clock

Deposits: ☐ None ☐ Mud ☐ Sludge ☒ **Debris** ☐ Grease

Silt Depth: **2** (in.) Deposits Extent: **Medium**

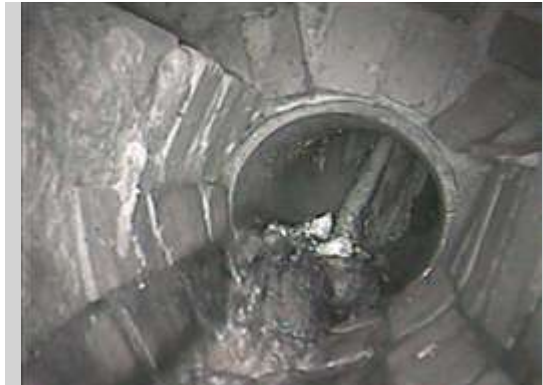
Drop In @ 6 O'Clock

Drop: **Outside** **Direct**

Inv Depth: **12.06** (ft.)

Drop Condition: **Open**
